TECHNICAL REPORT NO. 3-680

IMPROVED BEACH MATTING FOR U. S. NAVY AMPHIBIOUS OPERATIONS, ENGINEER TESTS JANUARY-AUGUST 1964

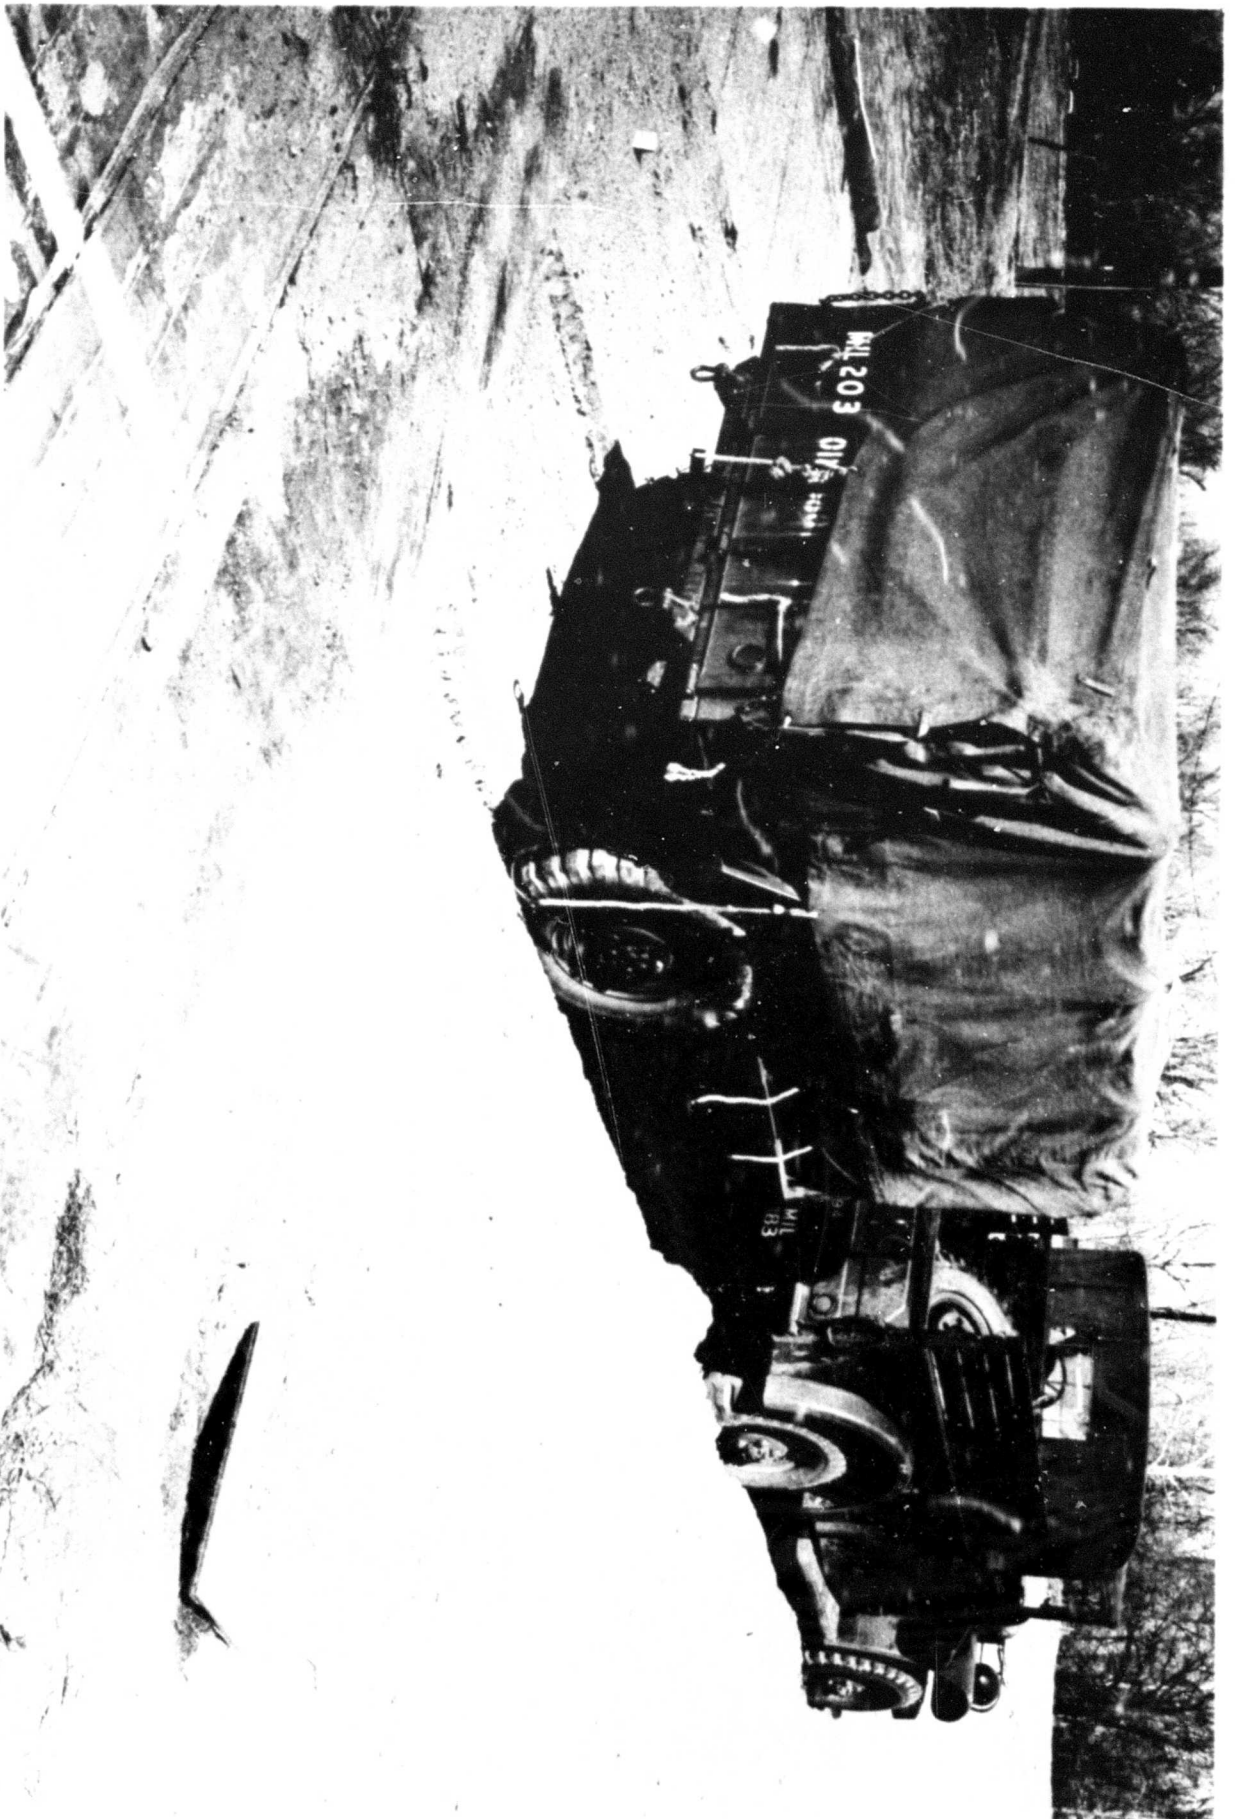
Photograph 10. M37, 3/4-ton, 4x4 truck with M101, 3/4-ton trailer immobilized on sand test section

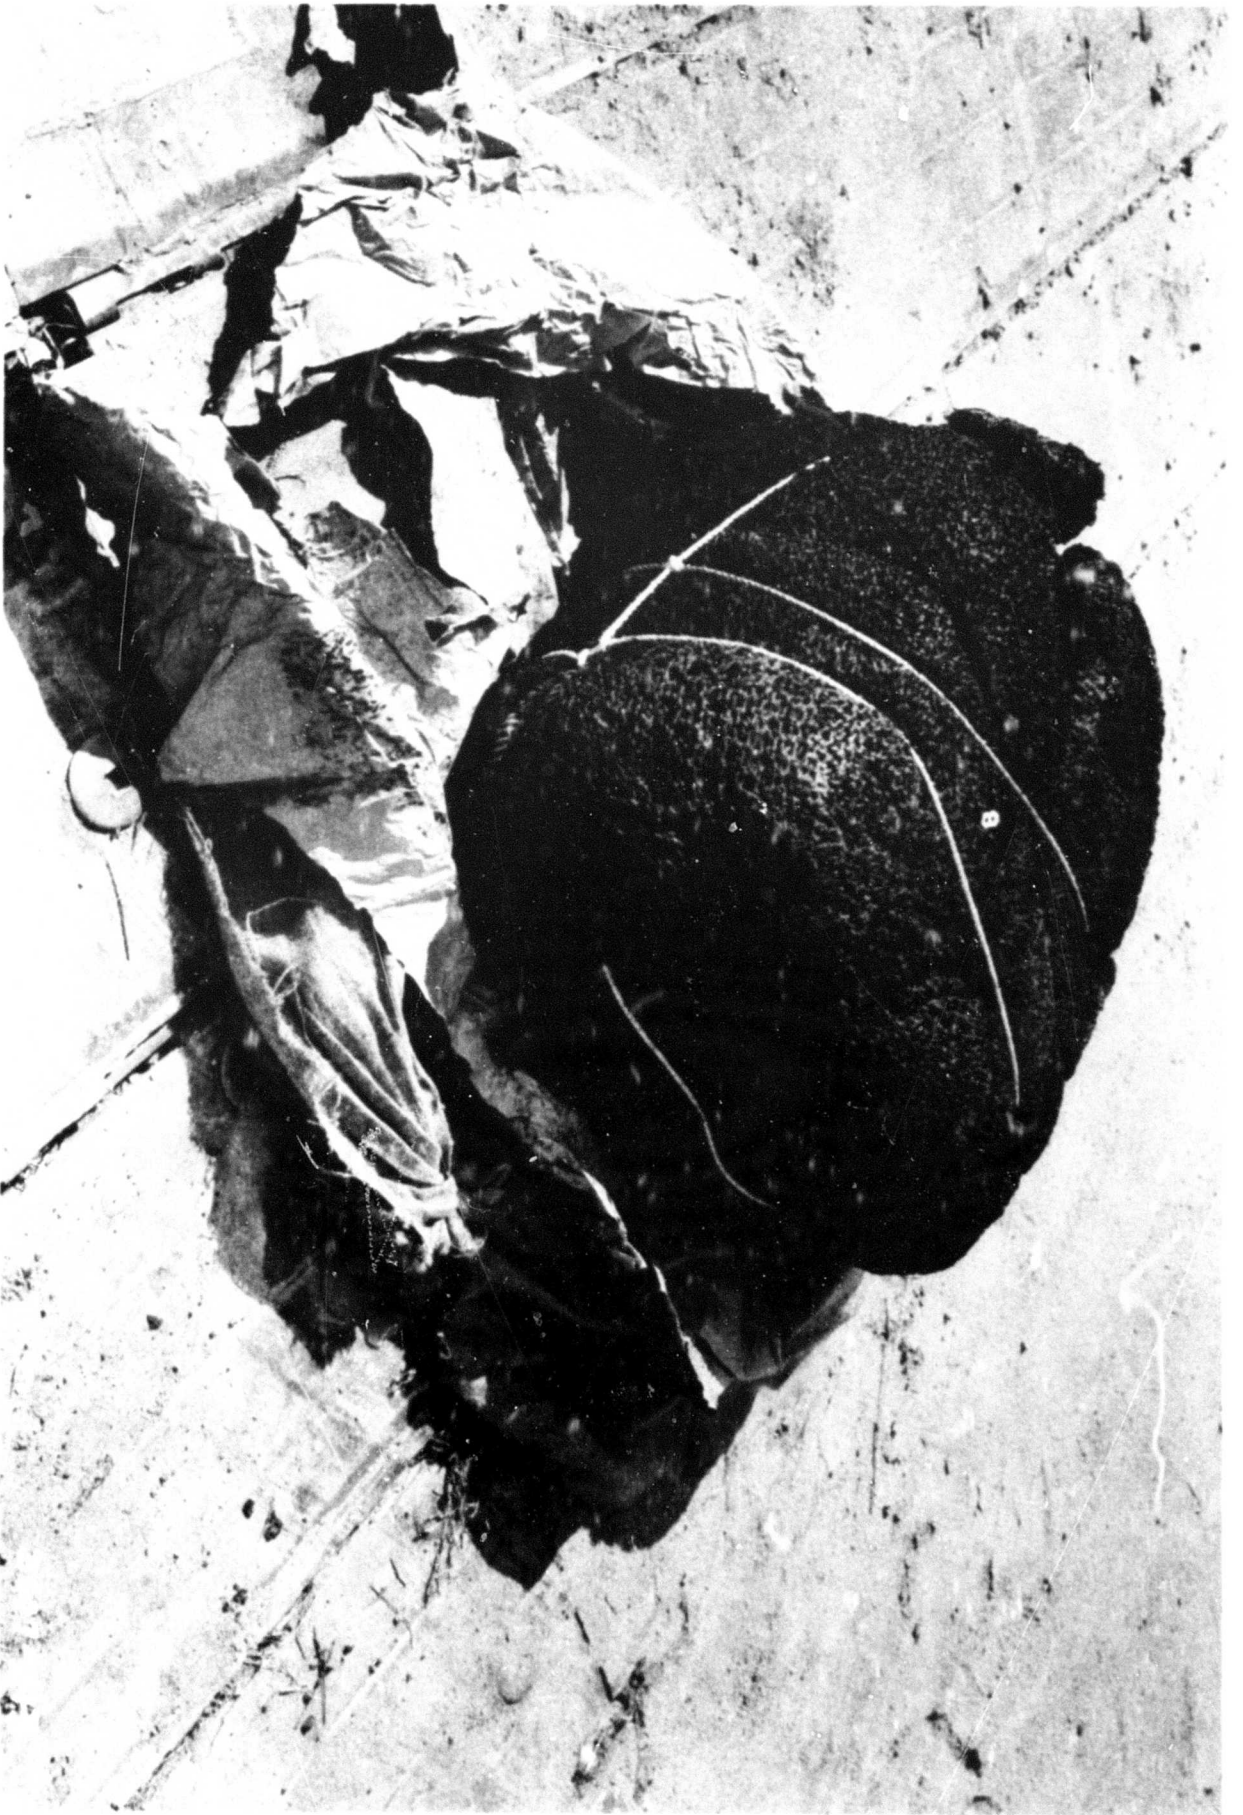
Photograph 13. Item 1 as received from manufacturer

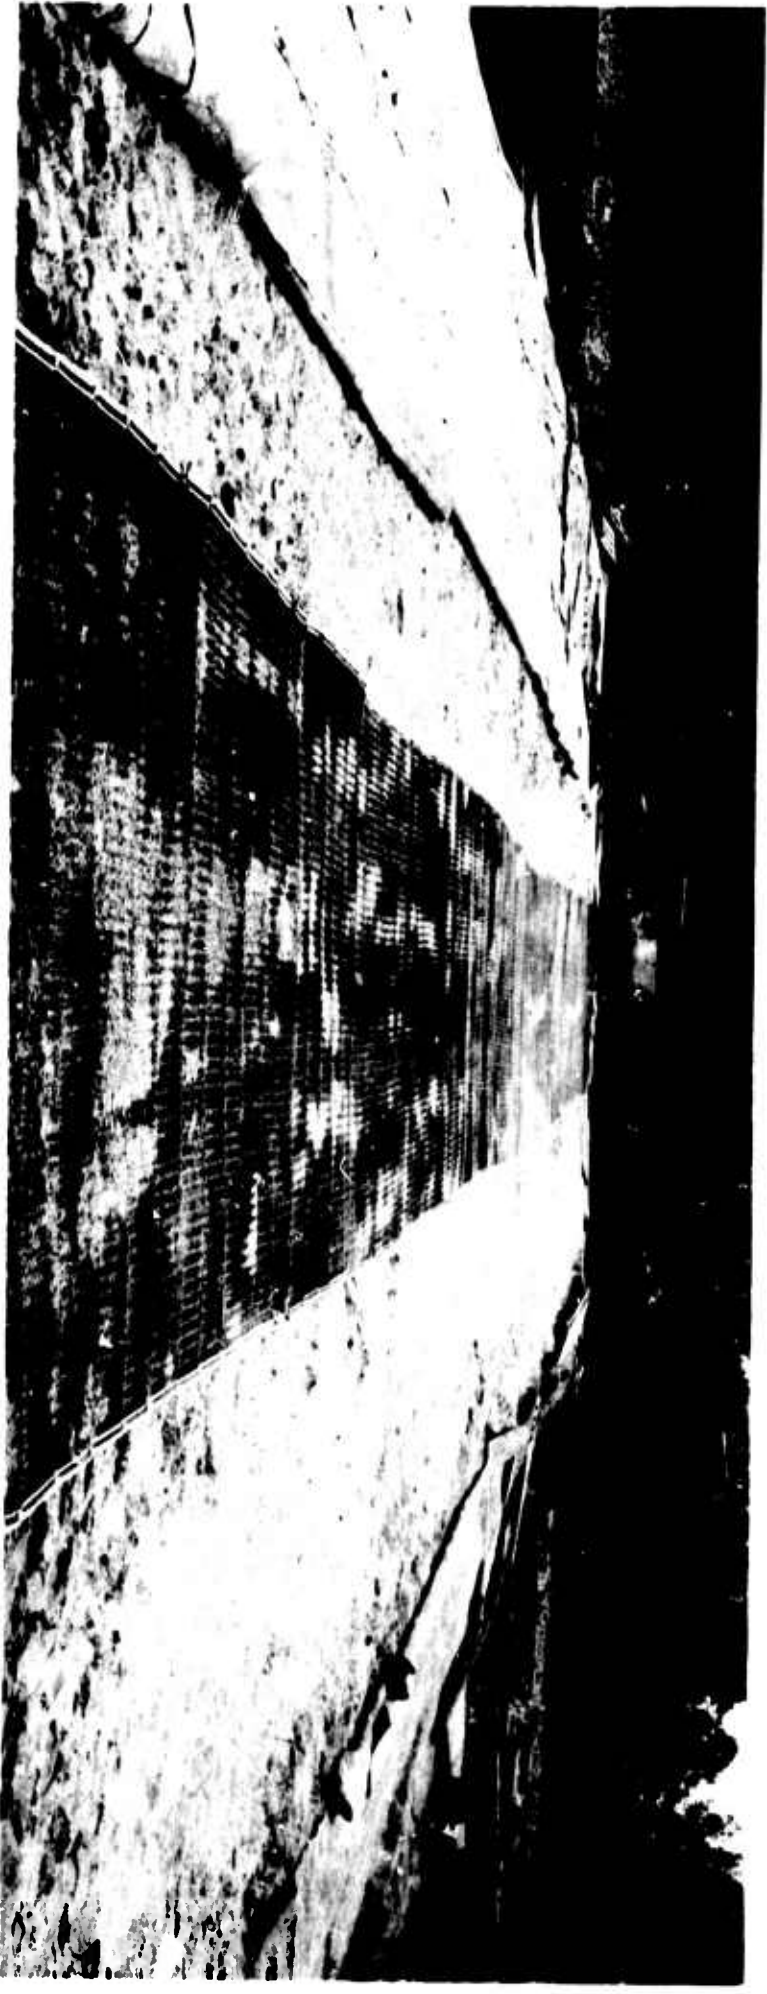
Photograph 43. Woven wire mat after initial pass of M36A1 jeep with trailer

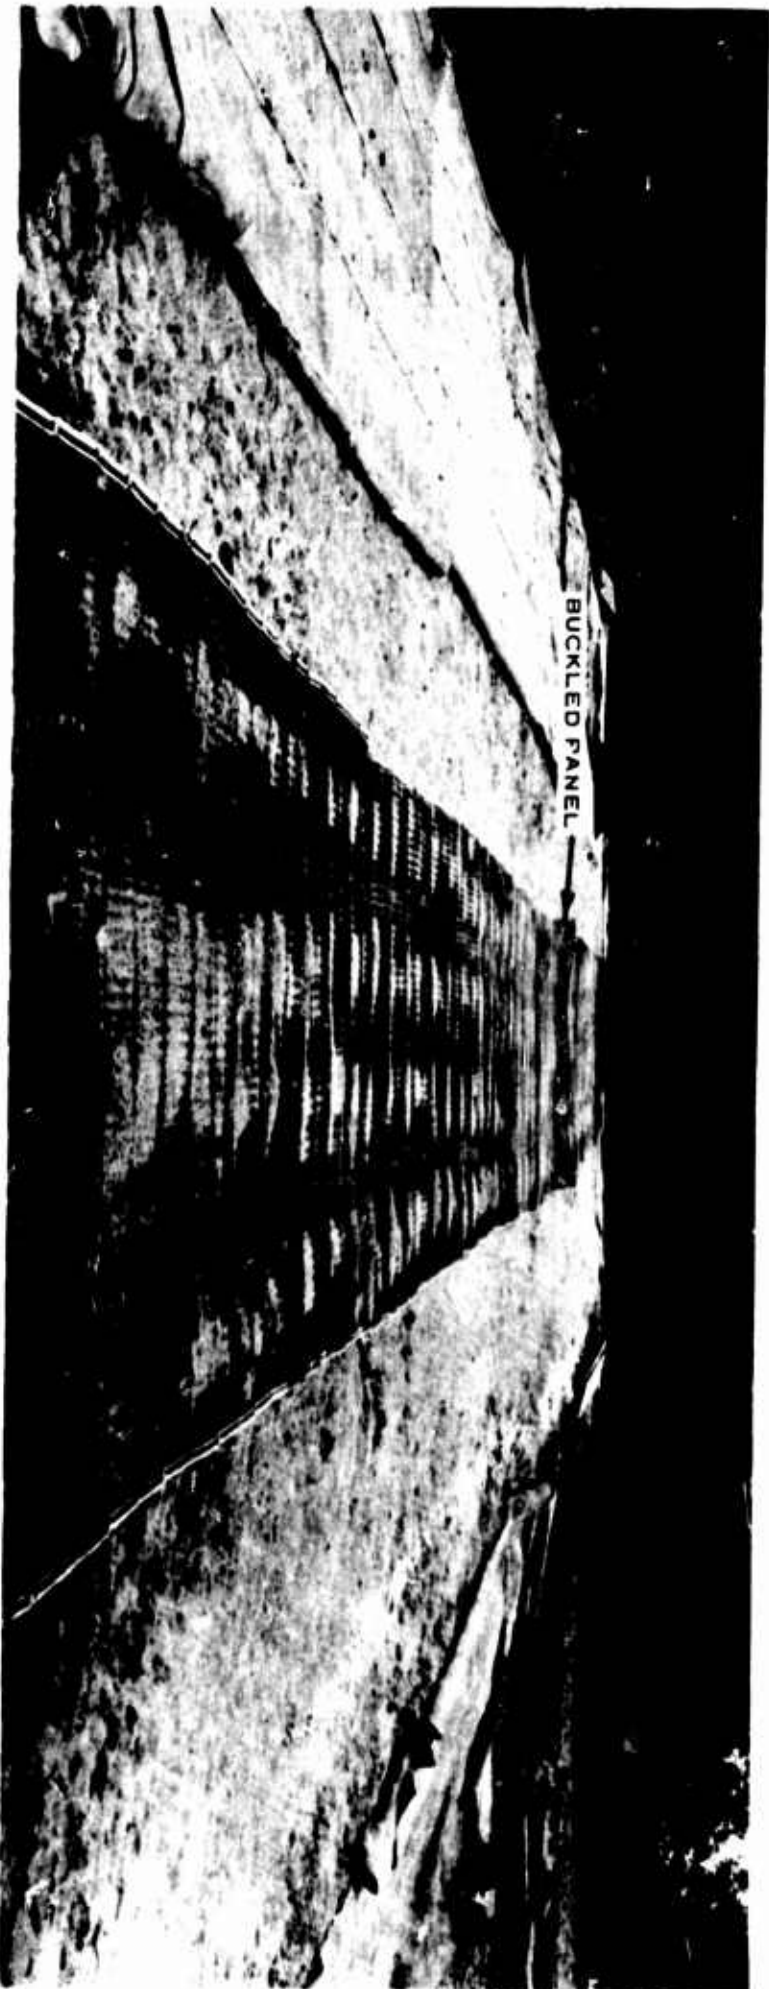
Photograph 45. Woven wire mat after initial pass of M37 truck with trailer.
Note buckled panel near upper end of test section

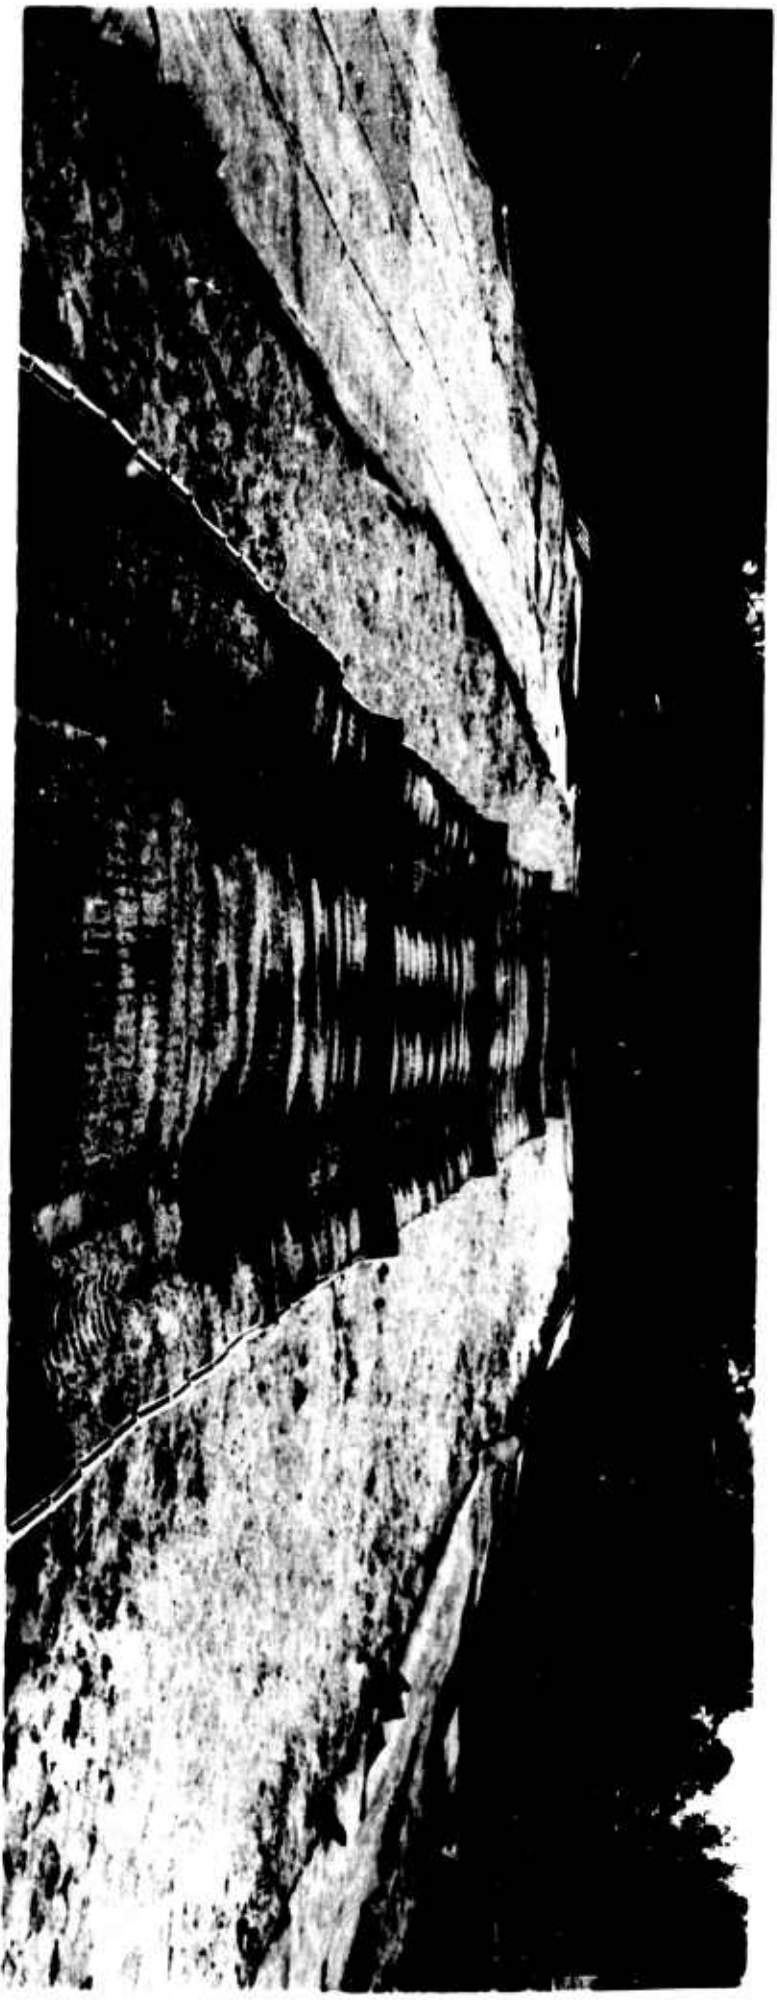
Photograph 47. Woven wire mat after initial pass of M54 truck with trailer
